CITY OF BALTIMORE WET W SMOKE AND DYED W	Page 1 of 3	
Sewershed: JONES FALLS	Company: REI/DRAYCO	Date: 06/18/08
Test to be Performed: SMOKE	Ground Condition: DRY	Supervisor: ER
Manhole ID: S37QQ_028MH	Test ID: 0994-353	Notifications Made:_X (Residents, Fire, 311)

CITY OF BALTIMORE SMOKE TESTING OBSERVATION SUMMARY JONES FALLS SEWERSHED

BALTIMORE CITY PROJECT 994 REI/DRAYCO

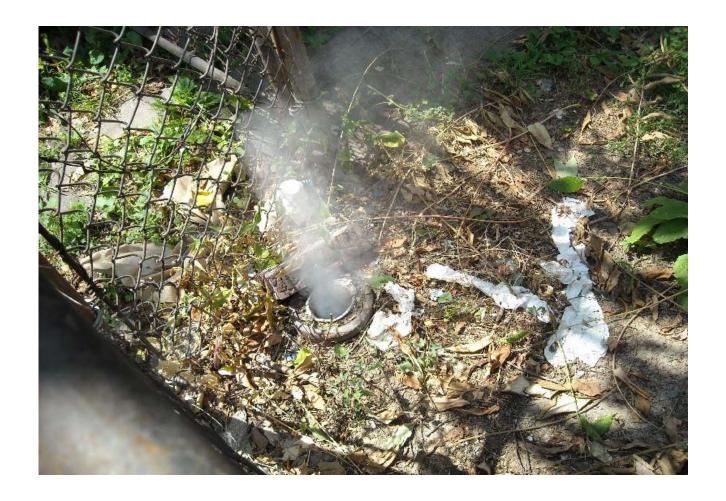
Photograph No: OB01-01 Filename: 0994-353_OB01-01.jpg

Unique Test ID: 353	Date: 06/18/2008	Basin: JF-19
Defect No: 1	Supervisor: E.R.	Dye Test Recommended: N
House No: 611	Street Name: BARTLETT	Street Type: AVE
Source Type: 03	Location: 08	Severity: 03
Sector: 02	Drainage Area: 0

Comments: CLEAN OUT - ABOVE GRADE. MISSING CAP.
